Volume II

Appendix D.7

Working Scenario

The Working Scenario was the result of a joint effort between the Columbia Accident Investigation Board (CAIB) and the NASA Accident Investigation Team (NAIT). The report was written beginning early in the investigation to track the current understanding of the events that led to the loss of *Columbia*. As such, the report evolved over time as facts became known, theories were developed or disproved, and NASA and the Board gained knowledge of the accident sequence.

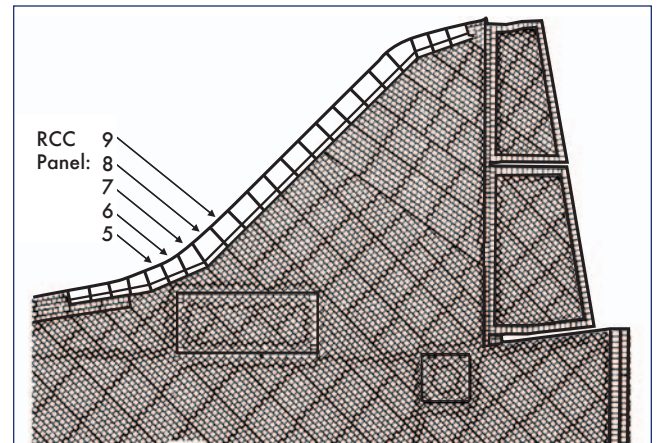
Several approaches were taken to assess the area of left wing damage. The efforts included launch video and photograph analysis, review of launch MADS data, debris transport analysis, forensic analysis of debris found in Texas, wire bundle burn through analysis, and aero/thermal modeling of the entry. The data indicate that the area of the highest probability of damage to the left wing was between RCC panels 5 and 9, with the most likely damage occurring on the lower side of RCC panel 8 or an adjacent Tee seal. The damage was most likely equivalent in size to a 6 to 10 inch diameter hole or area broken from the RCC panel or an adjacent Tee seal. Figure 3-4 shows the area of highest probability of wing damage and Table 3-1 shows the methods used to determine the damage.

Figure 3-4. Area of most likely wing damage.

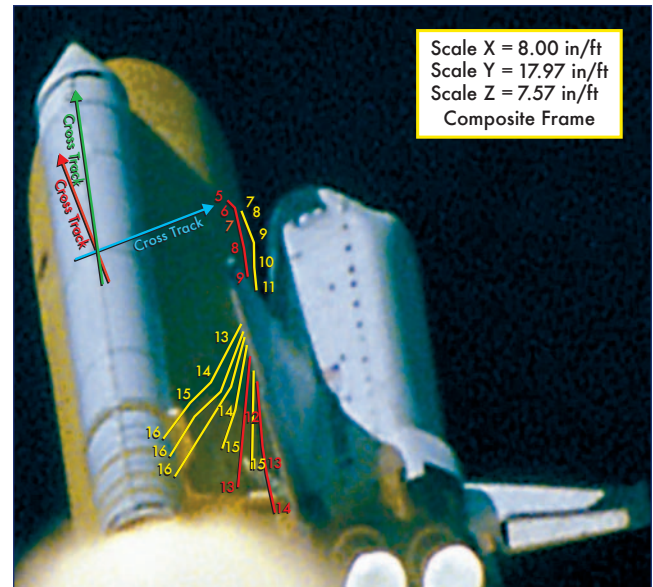
Enhancements of the ascent video indicated there was no discernable damage to the orbiter wing leading edge or lower tile surface. Figure 3-11 is a sample of these video enhancements. The figure compares 30 pre-impact integrated video fields with 21 post-impact integrated video fields. Based on these enhancements, photo experts have been unable to determine or quantify any damage to any portion of the orbiter vehicle as a result of the impact.

Figure 3-11. Pre-impact vs. post-impact shows no observable damage within the resolution limits.

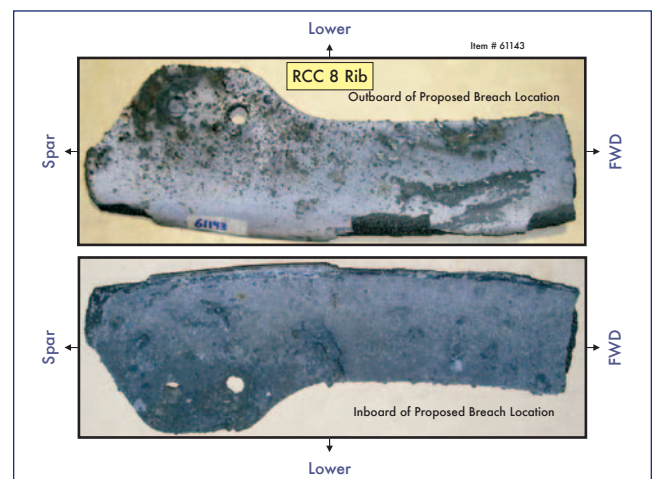
Figure 5-3. Samples of severe slag deposition on the panel 8 rib.

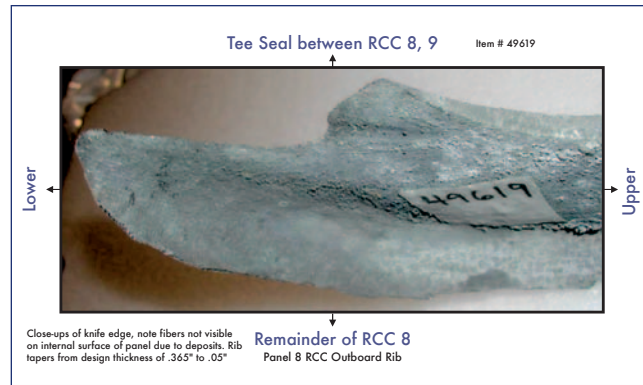
This forensics analysis further corroborates the breach location to be the lower portion of RCC panel 8 below the apex, approximately midway between the apex and where the RCC panel meets the carrier panel. Based on the flow

Figure 5-4. Example of rib erosion.

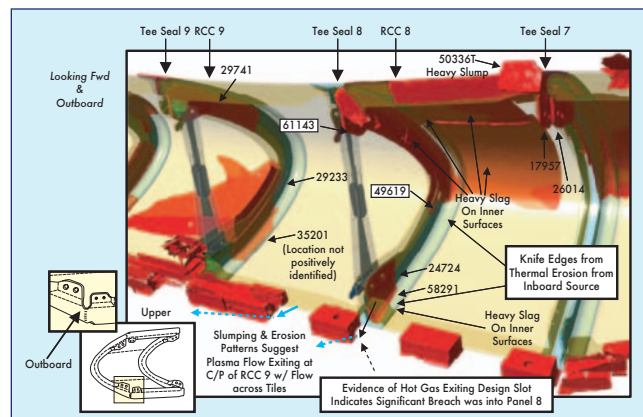
Figure 5-6. CAD drawing of the recovered debris showing overall slag deposition and erosion patterns.

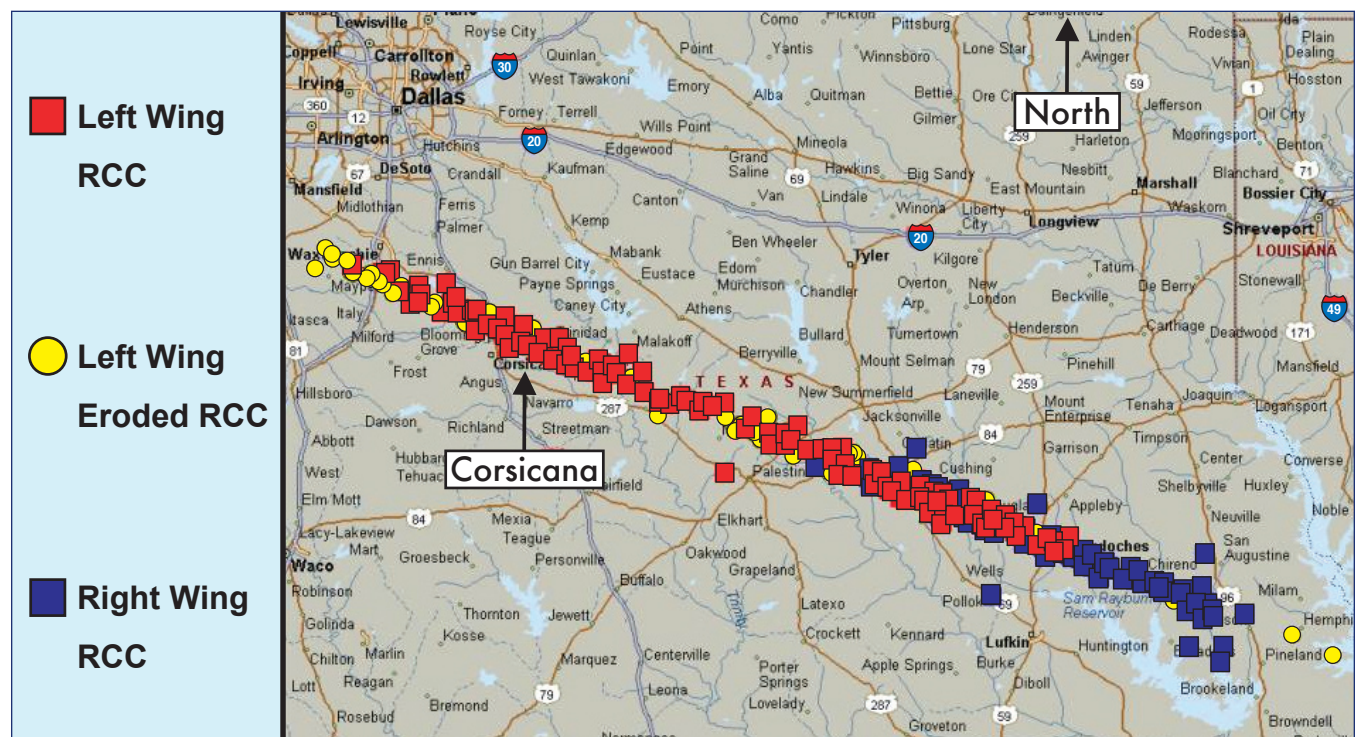
Figure 5-8. RCC panel debris location.

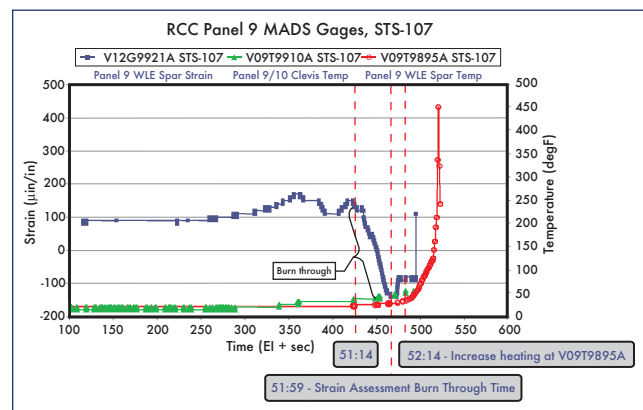
By 8:51:14 EST (EI + 425 sec.), the wing leading edge spar temperature began an early, off-nominal rise, shown in Figure 5-23. At the same time, the clevis temperature in the RCC panel 9/10 region continued to increase. The initial spar temperature rise was relatively slow and was caused by

Figure 5-23. RCC panel 9 MADS strain and temperature measurements, STS-107.

The first technique used the strain response, shown earlier in Figure 5-23. On this plot, the initial strain rise that began at about 8:49:09 EST (EI + 300 sec.) is due to thermal elastic strain. It appears that the spar structural softening occurs at approximately 8:50:09 EST (EI + 360 sec.), followed by loss of the structural integrity, or breach, at approximately 8:51:14 EST (EI + 425 sec.). This appears to be completed by approximately 8:52:00 EST (EI + 471 sec.). A detailed structural model that attempted to reproduce the thermal strain response observed during this timeframe confirmed this timing. This analysis determined that the location of the spar breach must be within about 15 inches of the spar strain measurement. This would locate the spar breach near the intersection of panel 8/9, as shown in Figure 5-29. The flow through the RCC breach maintained some directionality although it was influenced by the shape of the hole, remaining RCC structure, attach hardware, and leading edge insulators. Overall, this strain response is consistent with an RCC breach in the lower part of panel 8 as previously discussed in Section 5.3. Although it is difficult to pinpoint a precise location of the RCC breach, this analysis supports the argument that the breach was closer to the panel 8/9 intersection and Tee seal 8.

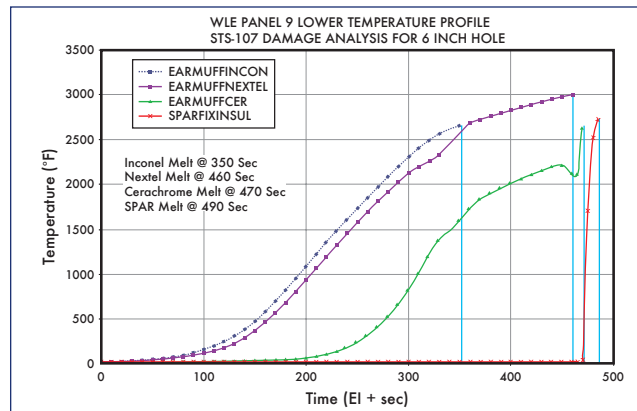
(EI + 490 sec.). This time would be accelerated slightly for a larger diameter hole. The results of this thermal model are shown in Figure 5-30.

Figure 5-30. Thermal model prediction of wing spar burn through.

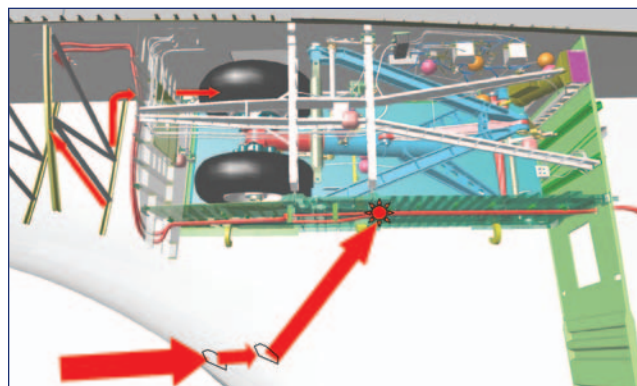
Immediately after the breach, hot gas inside the wing began to heat the remaining wire bundles that contained real-time telemetry and the recorded MADS measurements. Figure 5-29 shows an inside-the-wing view of the approximate breach location based on this wire failure analysis. The view on the left is of the panel 8/9 spar location. This area is not visible in the right photo, which contains the transition spar and a view of the three wire bundles along the outside of the wheel well wall. Figure 5-31 shows the overall spar breach location with respect to the rest of the wheel well. The distance from the spar to the wheel well wall in this area is approximately 56 inches, as shown in Figure 5-32. Figure

Figure 5-31. Hot gas begins to fill left wing.

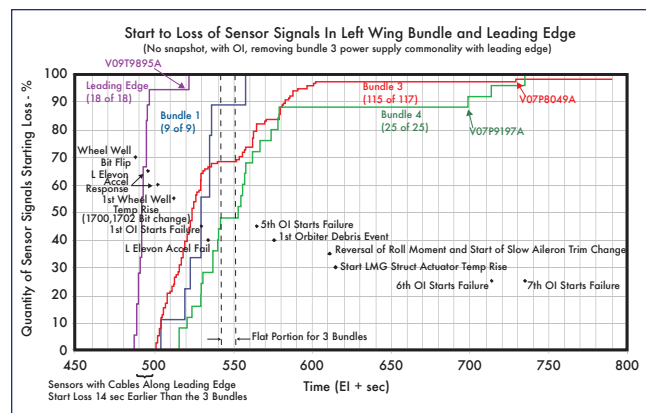
square foot per second (equivalent to the flight environment at about 8:50 EST, EI ~ 351 sec). During the test, the aluminum plate hole grew from 1 inch in diameter to 5 inches in diameter in approximately 13 seconds. This was consistent with thermal math models developed to analytically predict hole growth. A wire bundle placed 15 inches from the heat source showed very rapid erosion after the hole grew to 5 inches in diameter. The measurement losses in this bundle were very consistent with those observed for wire bundle number 3 (see Figure 5-34). The hole would have grown to a larger diameter; however, the test set-up provided a heat sink that eliminated further hole growth. Overall, the test indicated that a hole in the aluminum honeycomb would grow rapidly, allowing a substantial plume to destroy the wire bundles on the wheel well wall.

Figure 5-34. MADS data failure due to wire burning.

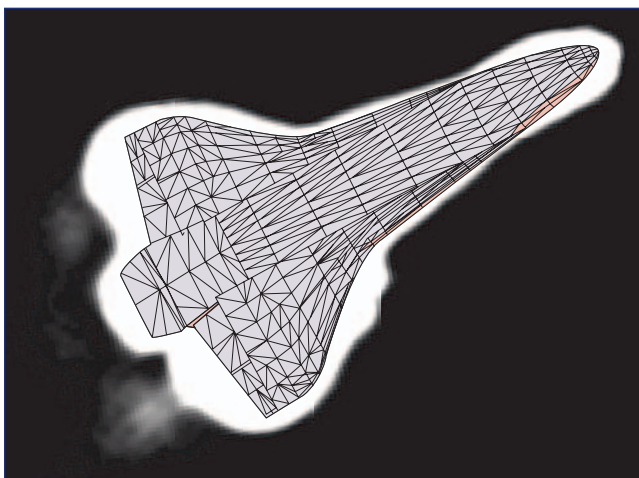
Figure 5-48. Kirtland photo with superimposed Orbiter outline.

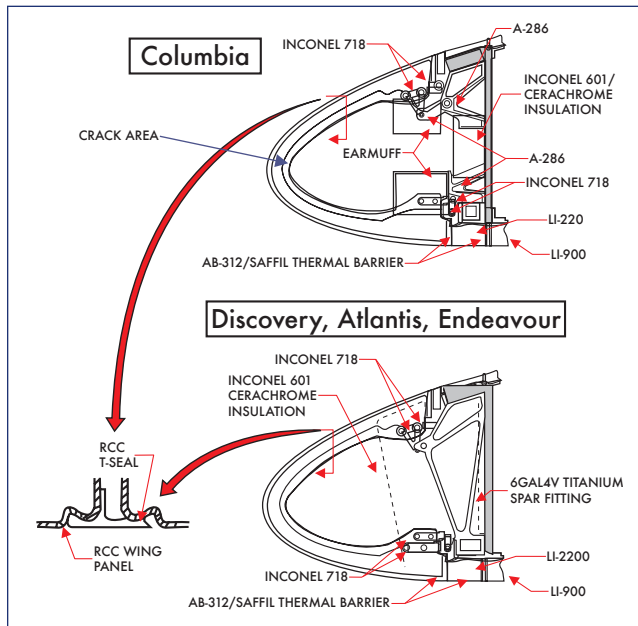
Figure 10-8. Tee seal crack location.

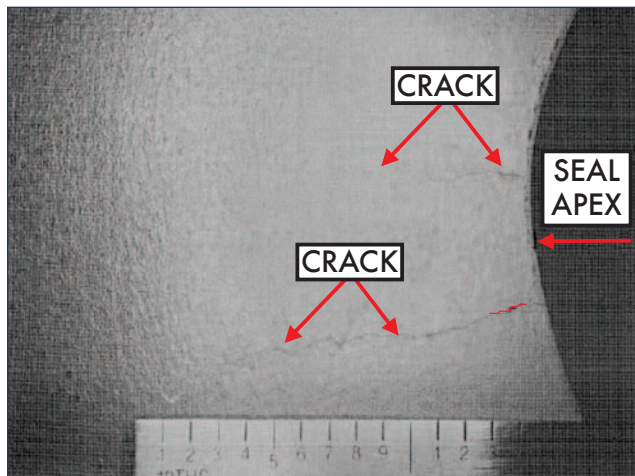
Figure 10-9. Tee seal cracking.

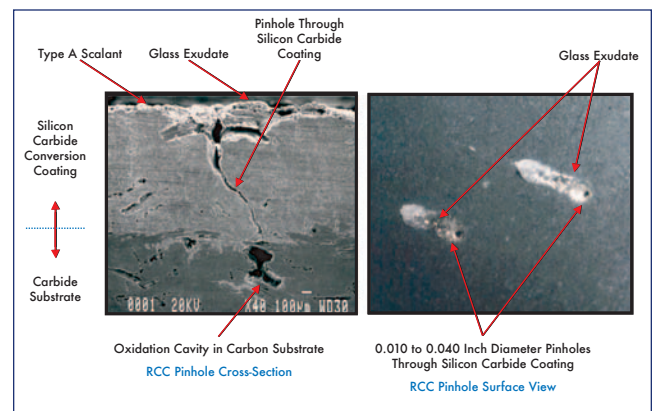
Figure 10-10. RCC pinholes.

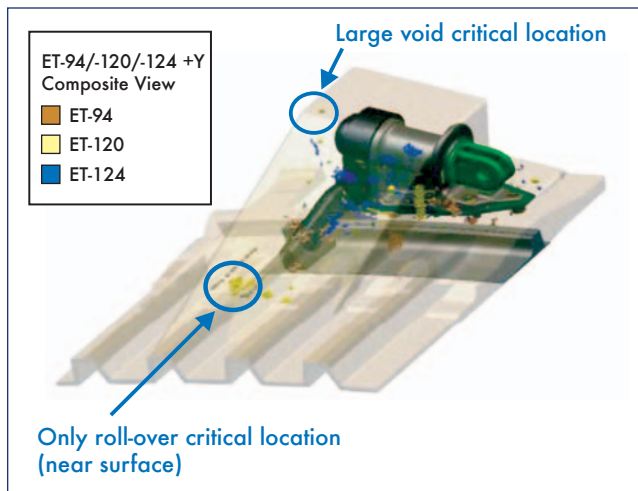
Figure 11-11. Defects found at critical locations.

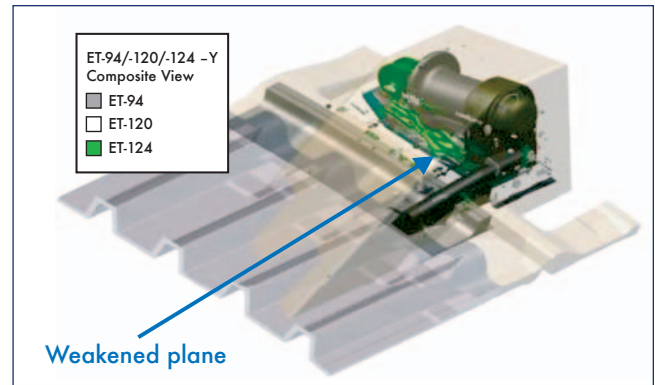
Figure 11-12. Weakened plane defect found.
